POL PIER REPAIRS
LAJES FIELD, AZORES

CONSTRUCTION INSPECTION VISIT NO. 3
SEPTEMBER 25 TO OCTOBER 3, 1980

CONTRACT NO. N-62477-79-C-0021
MODIFICATION P-00001

OLKO ENGINEERING
CONSULTANTS • DESIGNERS

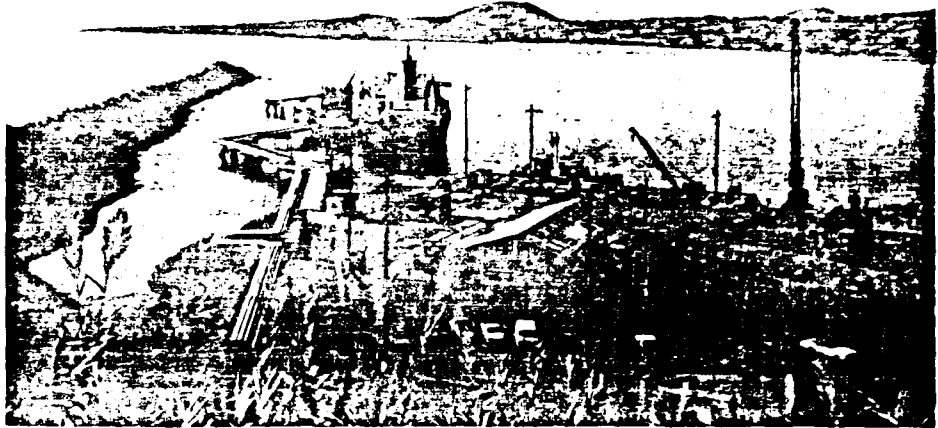
POL PIER - OVERALL VIEW
First Ship to Be Berthed - "World Promise" - After
the 100-Day Shutdown Period. Unloaded 41,000 BBL
of Diesel Oil

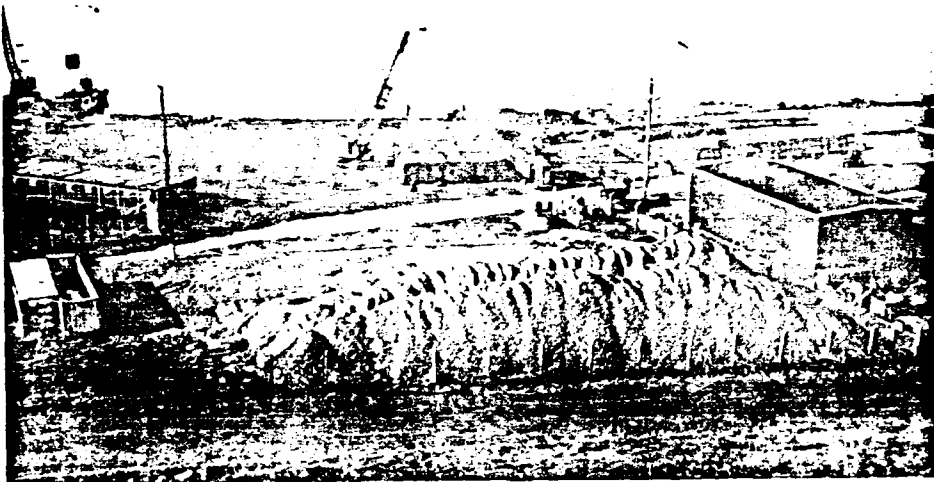
SHORESIDE - OVERALL VIEW

Crushed Stone Stockpiled to Be Used to Fill Both the New North and South Dolphins. Adjacent DANAC Workshop to Be Dismantled Upon Completion of Construction.

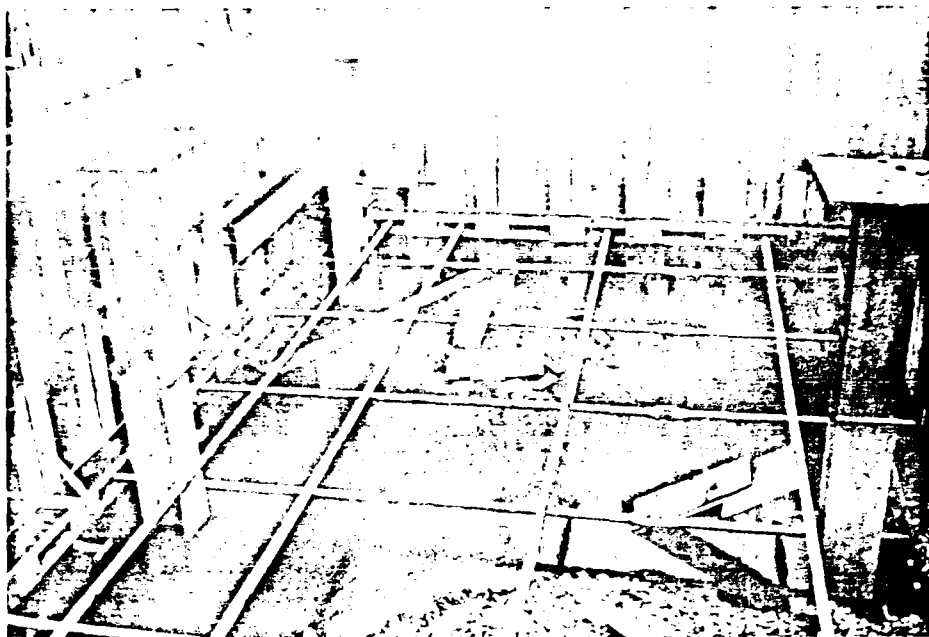
NEW NORTH DOLPHIN
Looking North at the Internal Water and Tie Rod System. The Cell is Partially Filled with Crushed Stone

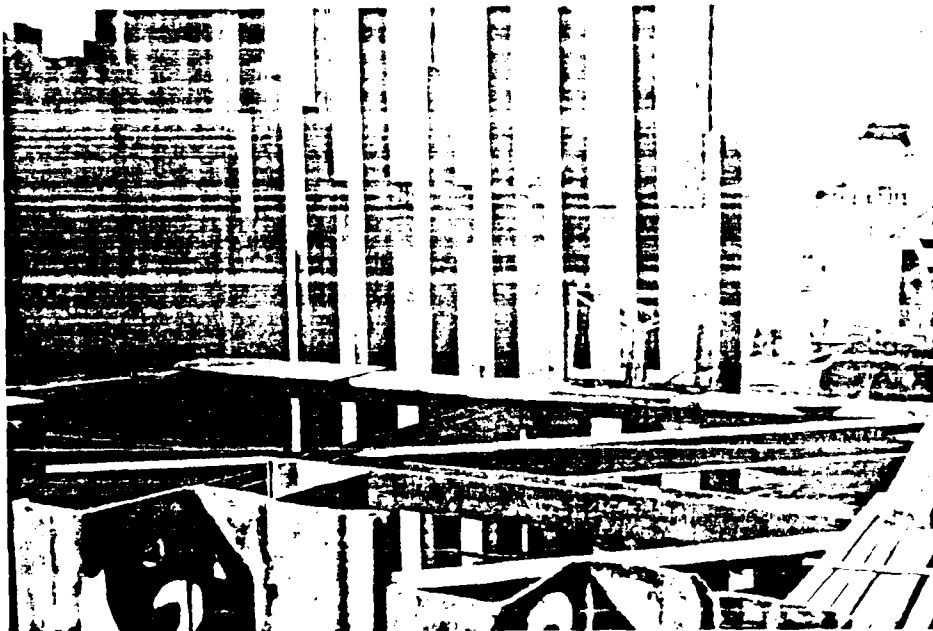
NEW SOUTH DOLPHIN

Looking West at Threading of the West Wall. The Soldier Beam Sheet Piles Are Placed First, Later, the Intervening Sheets Will Be Threaded.
